CLOSE CALL/HAZARD REPORT

Firefighter Struck by Fire Department Vehicle

10105 Jaydee Blvd, Fairfax Station

January 27, 2009

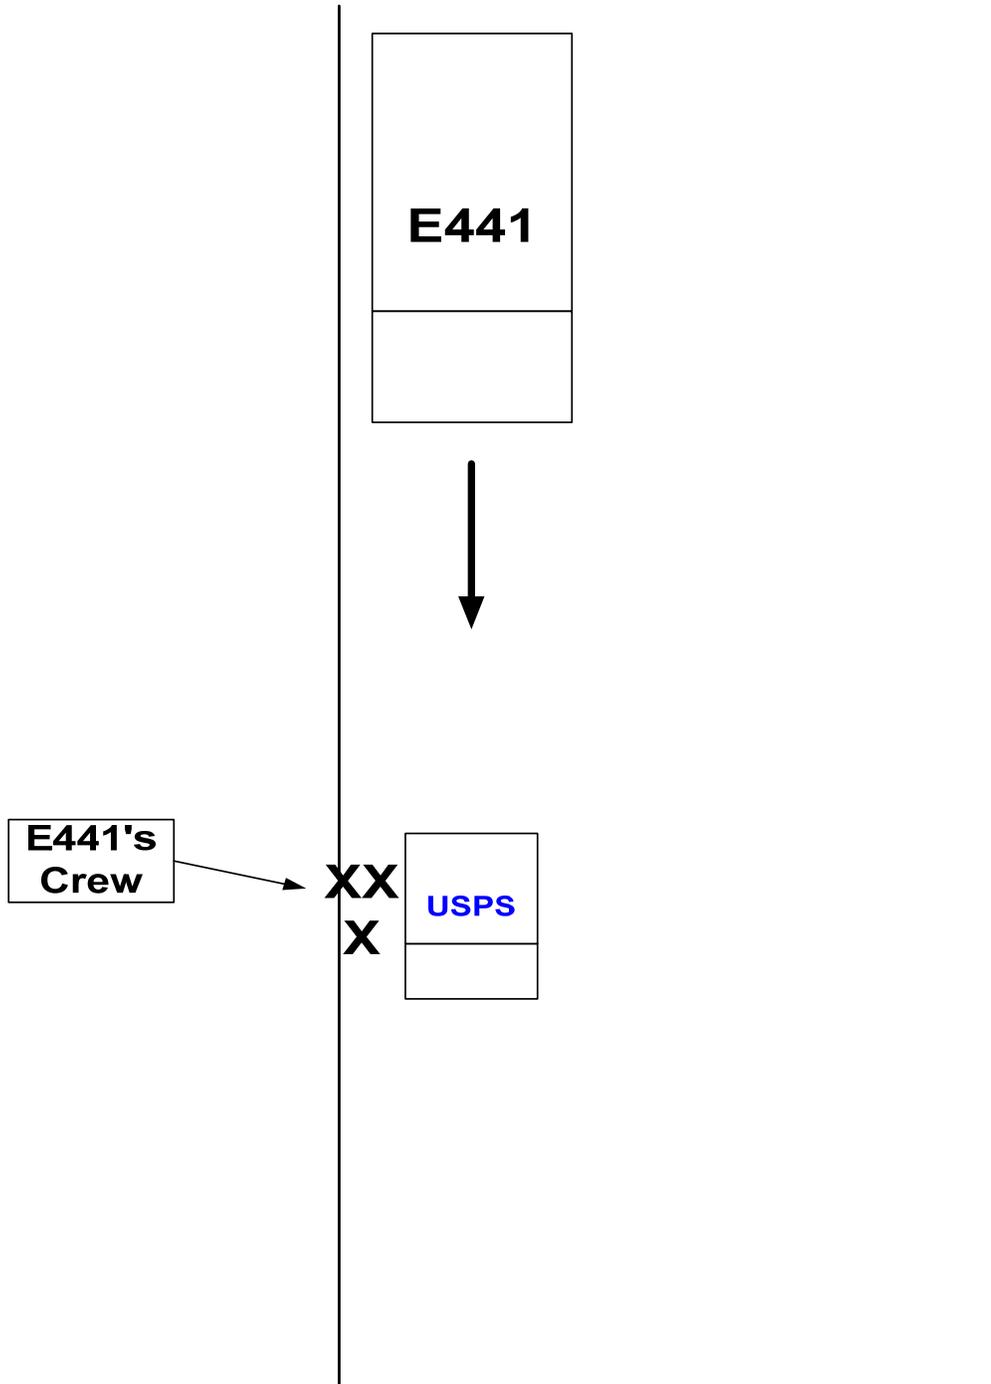
E441 Arrival on Scene

Engine 441 was positioned at the incident scene on the uphill side of an incline from the site of the injured person. The engine was parked parallel in the roadway within 50 feet of the postal vehicle near the injured person's location. The vehicle's wheels were left in a straight position and not turned towards the right side of the road.

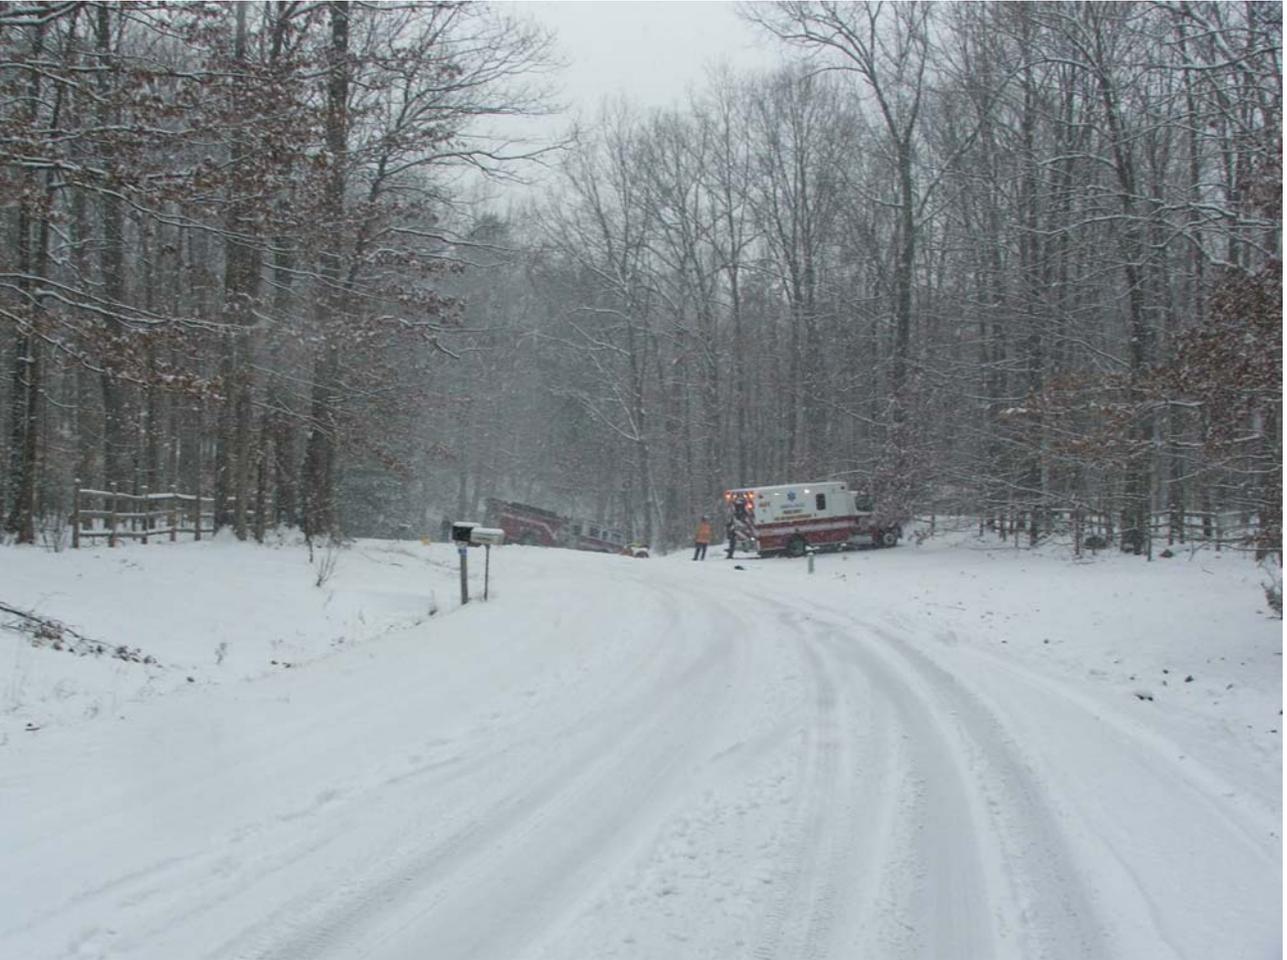
The rear of Engine 441 was just past the driveway where Medic 441 is located before it started sliding.

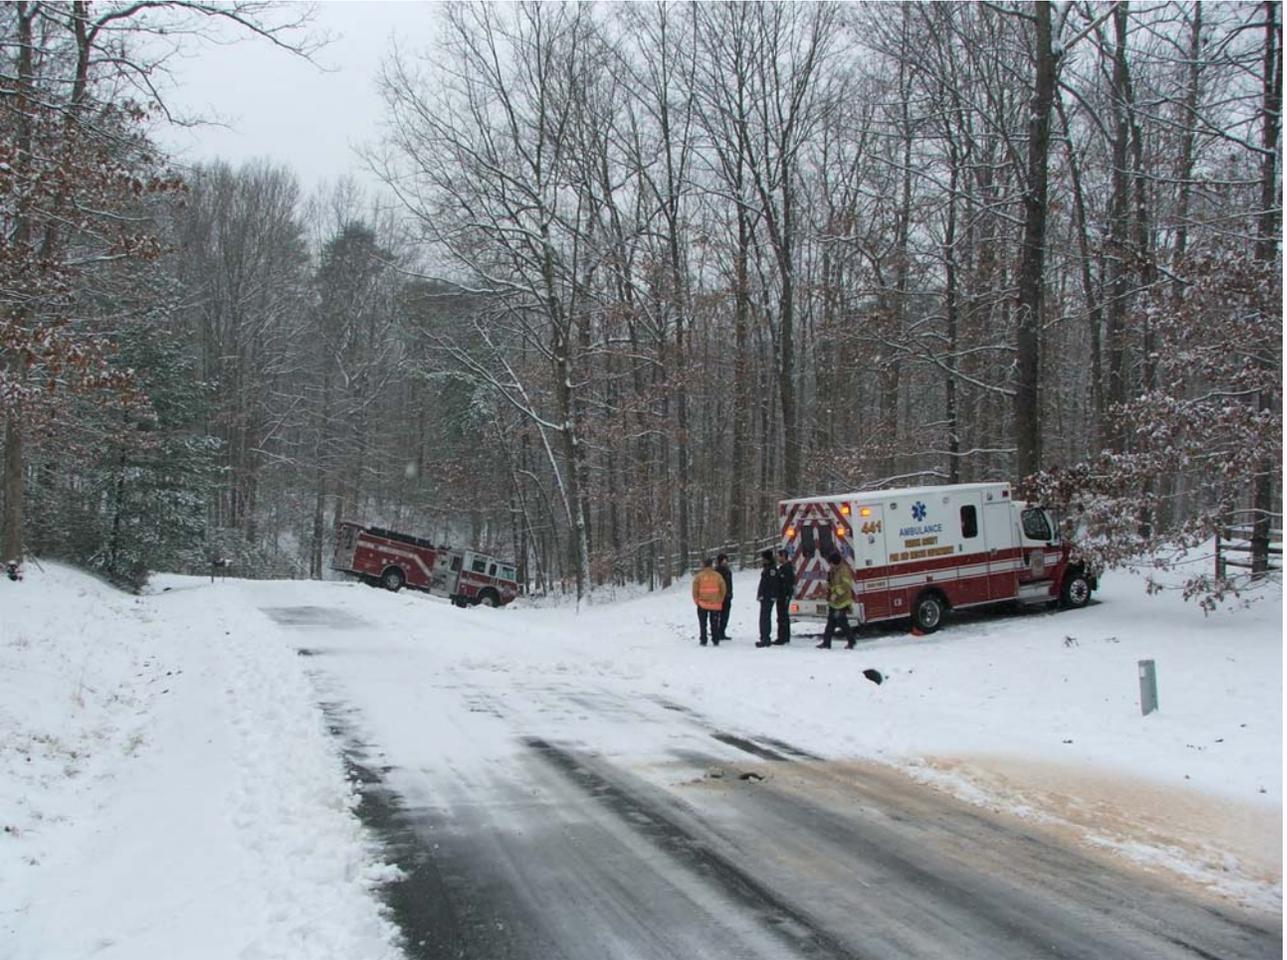
The scene after the road was plowed.

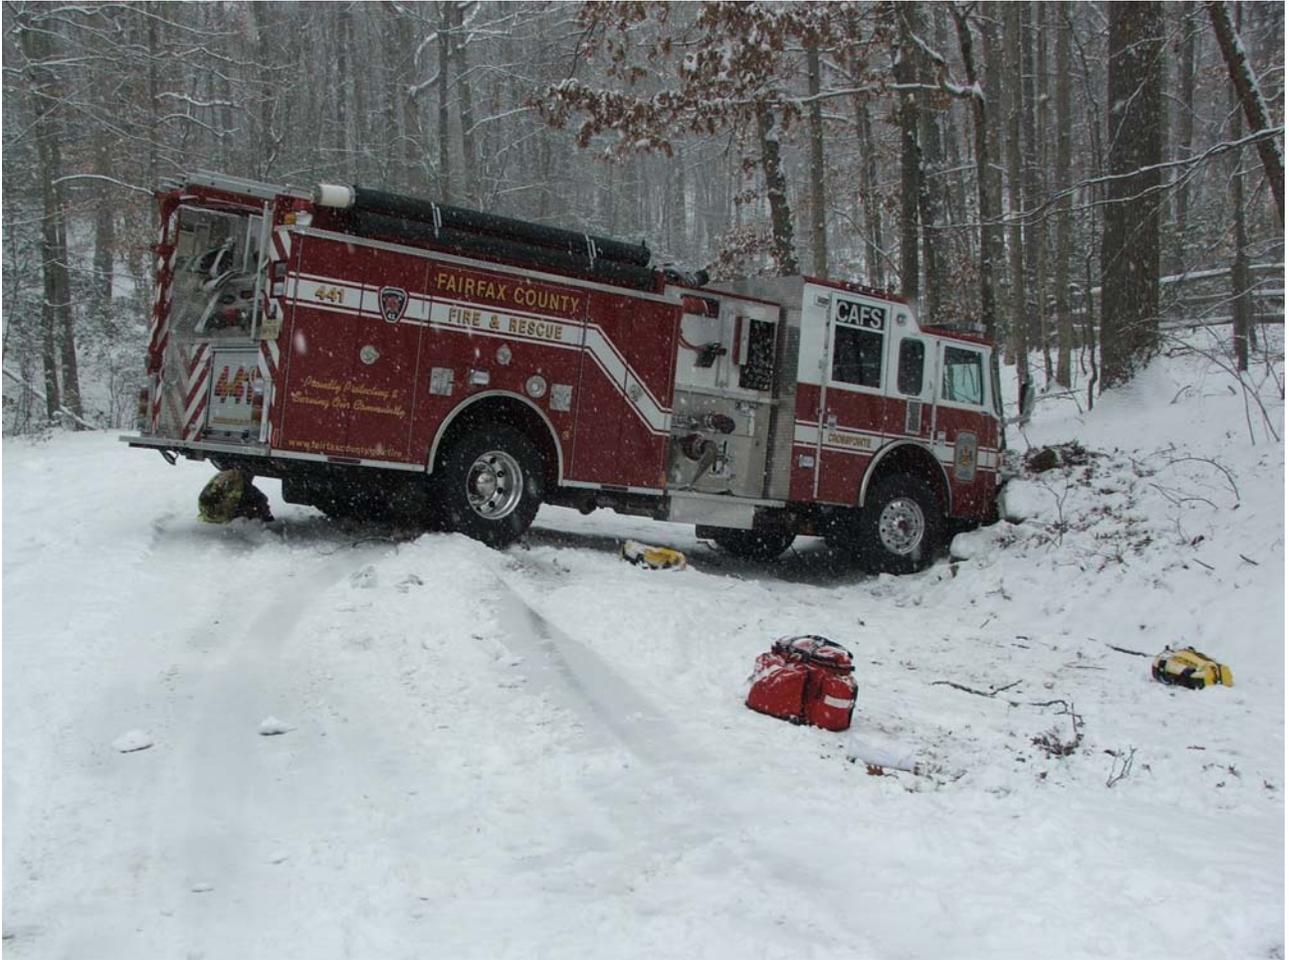
Engine 441's final location.

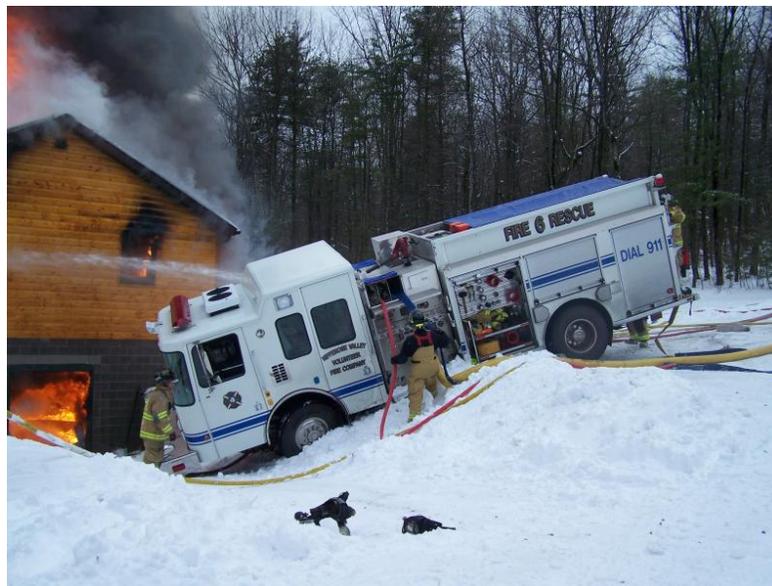
4. In February 2008, a Central Pennsylvania, Engine Company slid down a hill while pumping at a fire. It came to rest very near the well involved structure. (Photo below)
