CLOSE CALL/HAZARD REPORT

TRANSFORMER EXPLOSION
4060 FAIR RIDGE DR.
OCTOBER 25, 2006

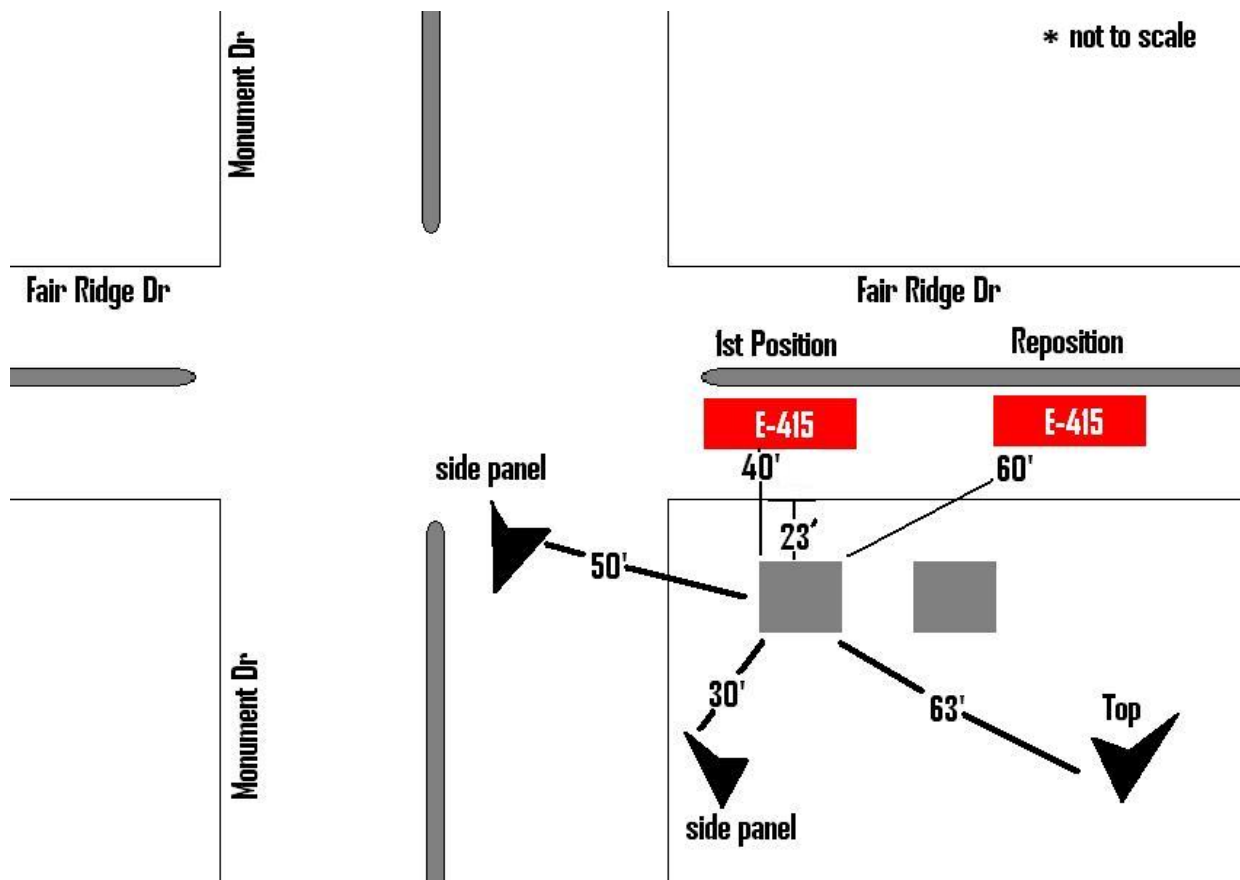
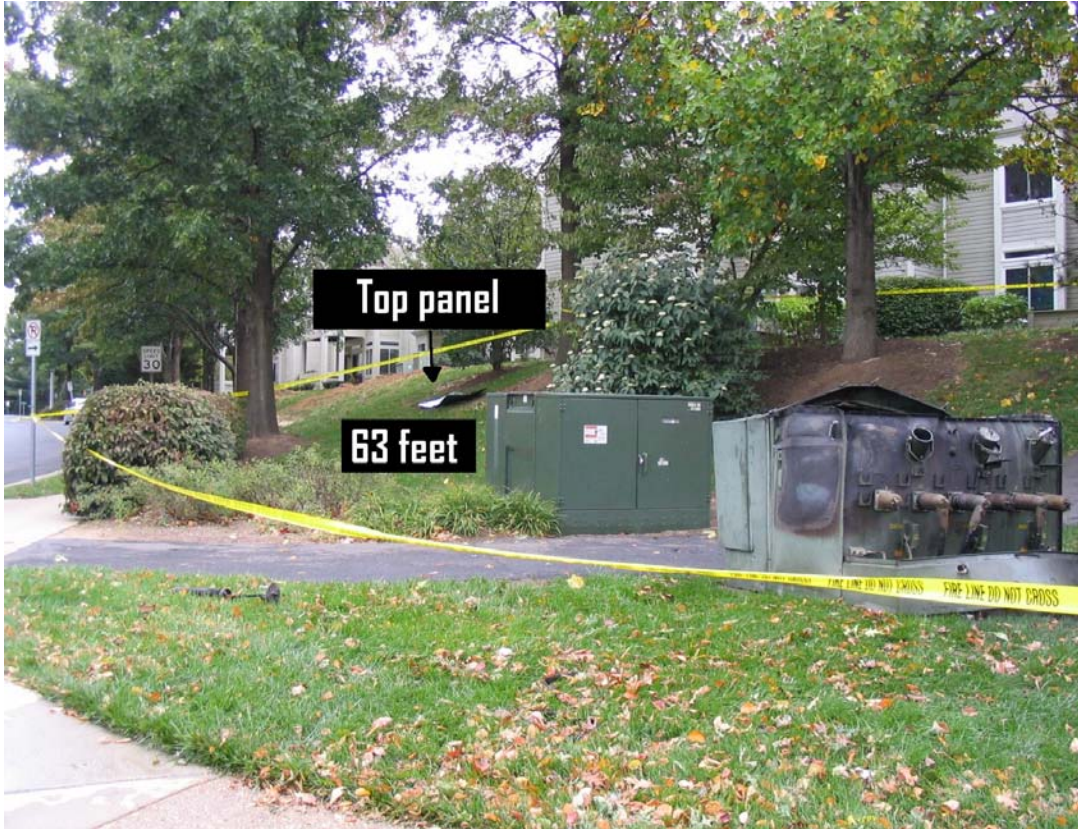
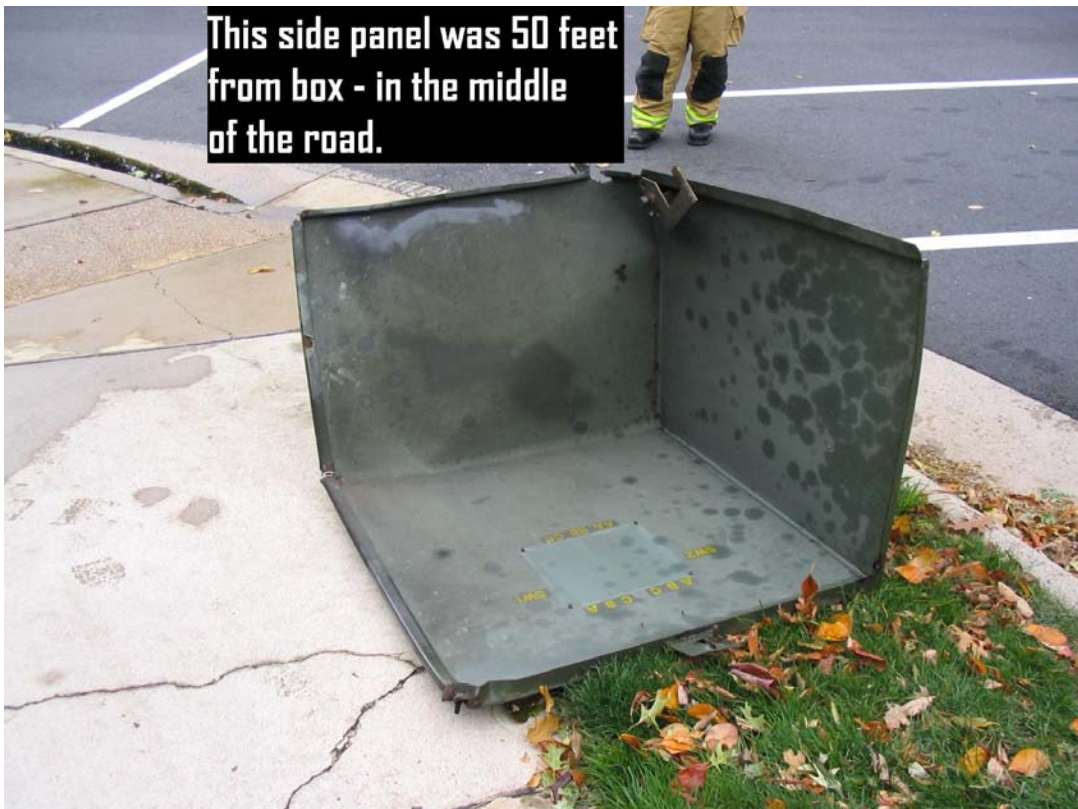
Three main parts of this heavy gauge metal box, two sides, and a top, were forced in three separate directions. The top was propelled 63 feet away; one side was propelled 50 feet, and another side 30 feet. The only direction where pieces of the transformer box did not explode was where the firefighters and the engine were originally positioned.

It was determined by Dominion Virginia Power that the cause of the explosion was due to mechanical failure inside the transformer.

- Handle switch box and transformer fires as HAZMAT calls
- If you have to approach, use full PPE w/ SCBA
- Position well away from the transformer
- Deny entry and cordon off the area
- Contact power company
- If the transformer is on fire, do not apply water or other extinguishing agents, or approach it until it is confirmed de-energized
- Look/Listen for scorching, leaking fluid, venting, smoke, and noises

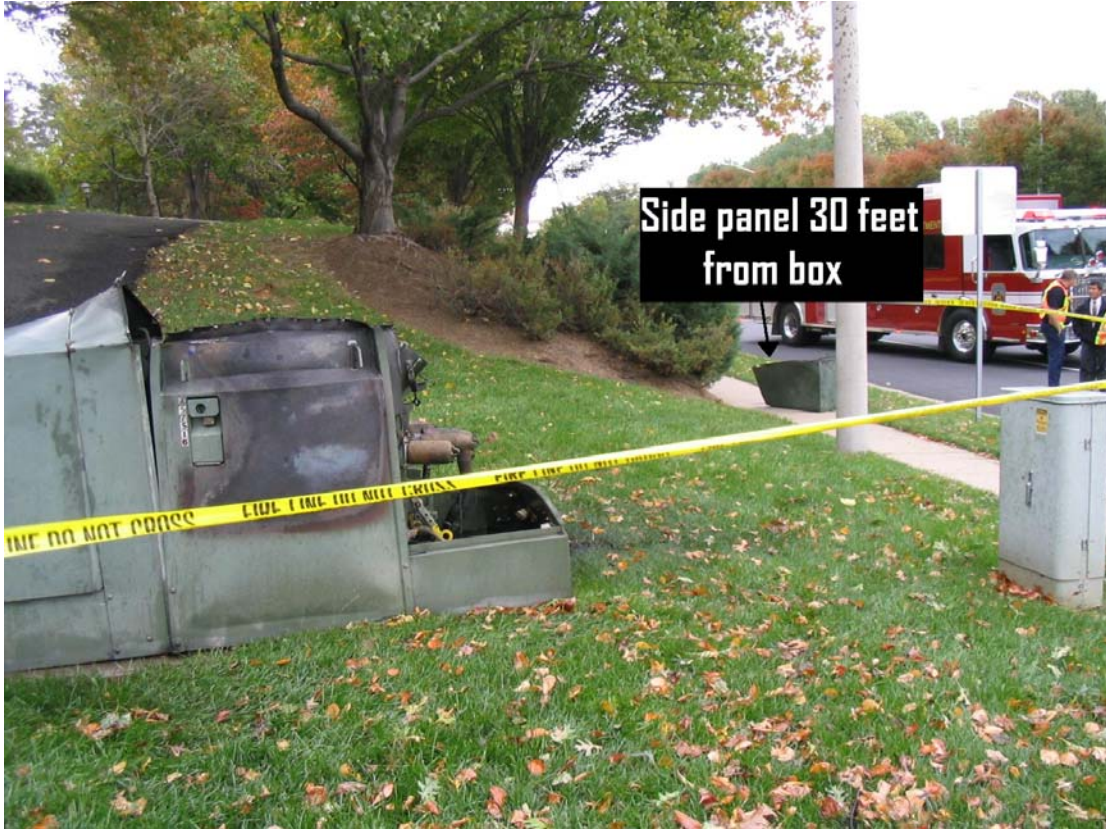
Side panel 30 feet
from box

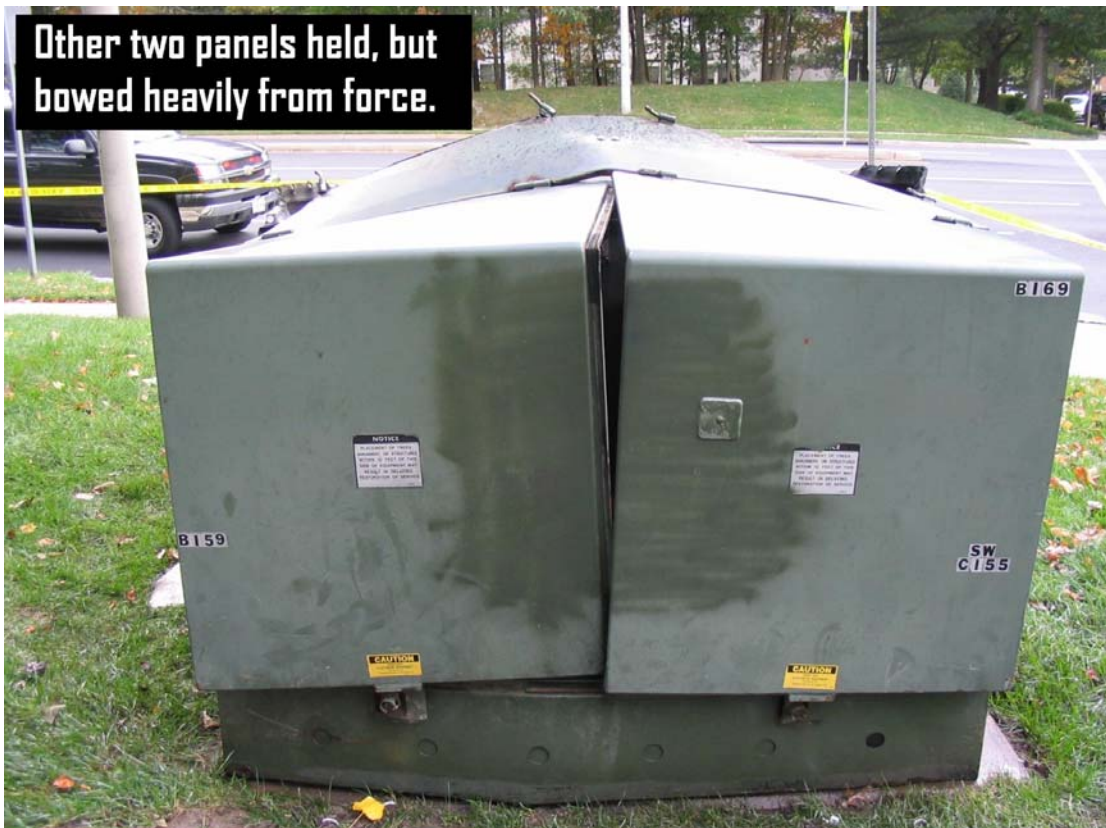
Other two panels held, but
bowed heavily from force.
