SAN BERNARDINO COUNTY FIRE DEPARTMENT

TAILBOARD SAFETY SESSION

NEW REINFORCED DRYWALL – LINED WITH LEXAN

Wall Breach Test

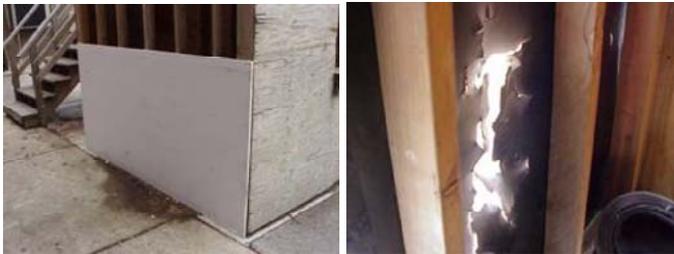
The test was conducted by utilizing 5 different hand tools that a firefighter will most likely have with him during firefighting operations. Each of the 5 different hand tools was used to attempt to breach the Hi-Impact 8000 Wallboard. The wall was constructed of wooden studs on 16" centers. The 4' x 8' sheet of wallboard was mounted to the studs using ordinary drywall screws. The wall is pictured below:

As shown in the table above, all of the striking tools were proven ineffective in breaching the Hi-Impact 8000 Wallboard. The cutting tools proved to be most effective, usually penetrating the Lexan in less than 10 swings. The Lexan did not break easily after being struck but it did crack enough to become pliable enough to bend while the firefighter crawled through the hole.

It was demonstrated that breaching the Hi-Impact 8000 Wallboard has a high resistance to impact forces brought on by striking tools. The tool of choice when this product is encountered is a cutting tool. This test further stresses the fact that departments need to get out in their response areas (even auto or mutual aid areas) and know what kind of building materials are being used.
